Vibration Analysis of Rolling Element Bearings (Air Conditioning Motor Case Study)

Konstantinos Kamaras, Anastasios Garantziotis and Ilias Dimitrakopoulos
Email: cbm@fnt.gr

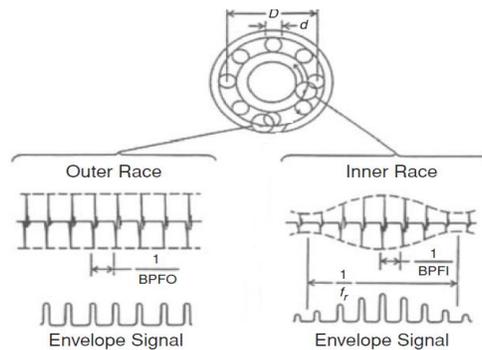
Figure 1. Process of envelope analysis.

Envelope analysis is based on the observation that bearing fault impulses are amplified by the resonance of the structure that supports the bearing or the bearing itself thus yielding a high signal to noise ratio. It is a three-stage procedure which is depicted in **Figure 1**. It involves the band-pass filtering of the raw vibration signal in a high frequency region where the fault impacts are amplified by structural resonances (Randal and Antoni, 2011). Then the signal is rectified and amplitude demodulated using an envelope detector such as the Hilbert transform. Finally, the spectrum of the envelope signal is calculated using FFT algorithm which usually can display the characteristic bearing defect frequencies at low frequency region efficiently. Typical patterns of the envelope signals of a bearing with outer race or inner race fault are depicted in **Figure 2**. Envelope analysis have been proven very efficient at detecting bearing faults or lack of lubrication at early stages.

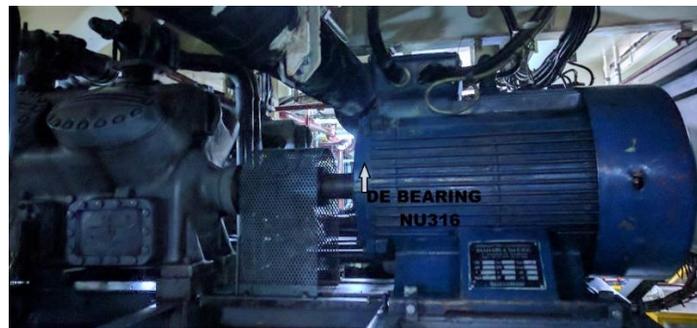
The machine of interest was the motor of a ship's air conditioning system that is composed of three coupling connected motors and compressors. The No 4 air conditioning machine was found with a motor d.e. bearing issue. The motor, which is depicted in **Figure 3**, is 105 kW, 1770 rpm and it has a NU316 Drive End (DE) and a 6316 Non Drive End (NDE) bearing respectively. The failure was diagnosed at the DE bearing (NU316- Koyo) using vibration analysis. The Digivibe MX9 vibration analysis software and a 100 mV accelerometer were used. The sampling frequency was 44.1 kHz and the diagnosis was based on FFT algorithm and envelope analysis. The measurements were carried out at motor d.e. and n.d.e., motor and compressor mounting bolts and compressor, compressor d.e. and n.d.e., compressor cylinder valves and frame in horizontal, vertical and axial directions.

Figure 3. Motor and compressor of ship's air conditioning system. The location of motor d.e. bearing is highlighted.

Prior to the vibration analysis measurements, it was noticed that the motor had an increased temperature at motor d.e. The maintenance personnel reported that motor bearings were replaced six months ago and were lubricated according to the manufacturer's guidelines. However, the vibration analysis showed a motor d.e. defect and the maintenance department was advised to replace the bearing as soon as possible.

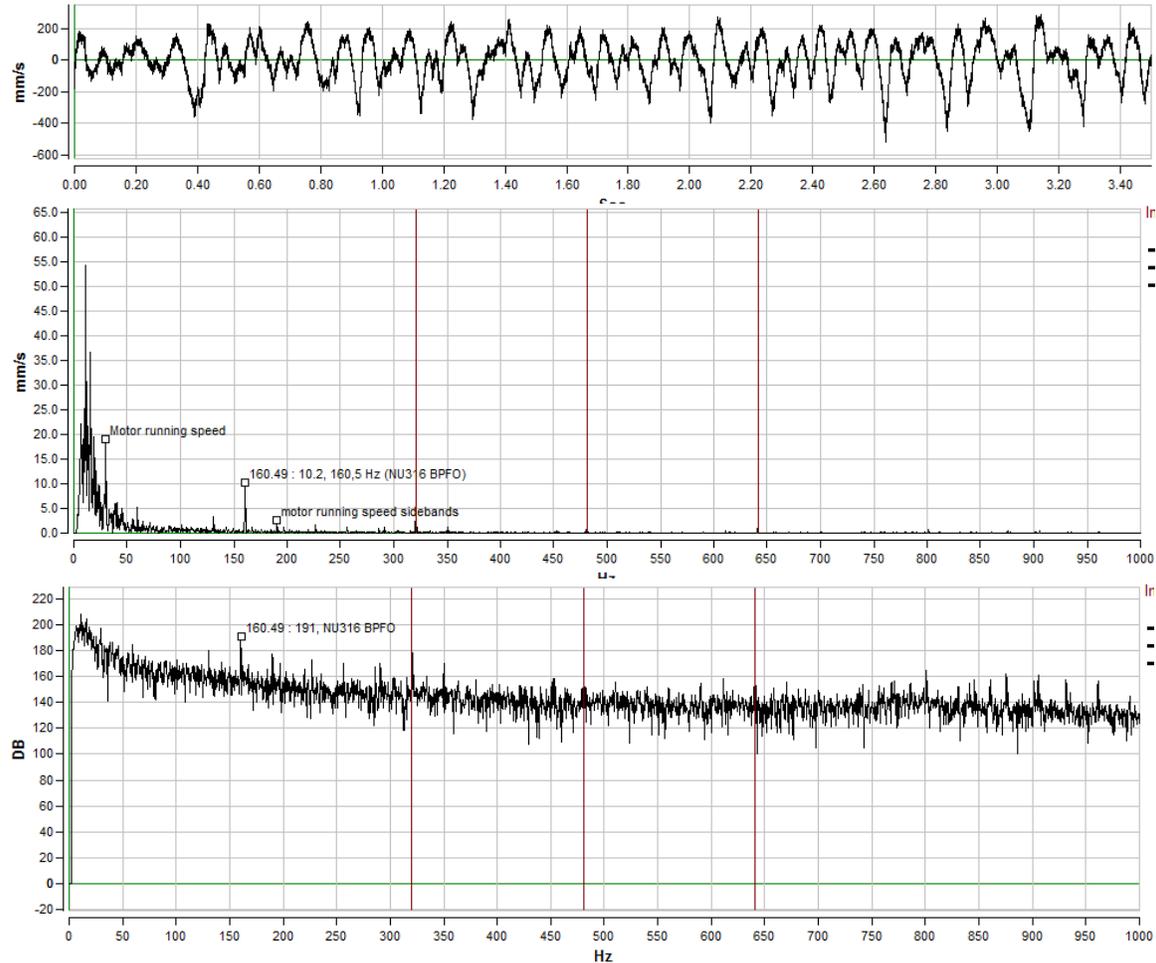
The vibration analysis low frequency (velocity) waveform and spectrums at motor d.e. in horizontal direction are depicted in **Figure 4**. As it can be observed apart from the high level of the fundamental frequency of 29.6 Hz (1X) that corresponds to motor running speed there is also a non- integer multiple frequency component of it 160.5 Hz (5.42X) which is related to motor d.e. bearing (NU316) CDF of BPFO. Harmonics of BPFO start

to emerge in the frequency spectrum which shows that the bearing failure is in a developed stage. The aforementioned harmonics are better recognizable in dB as it can be observed at **Figure 4** (bottom graph). Finally, sidebands of motor running speed were measured around BPFO thus showing modulation.

Figure 5. Motor d.e. velocity waveform (top), velocity spectrum in linear scale (middle) and in dB (bottom) respectively.

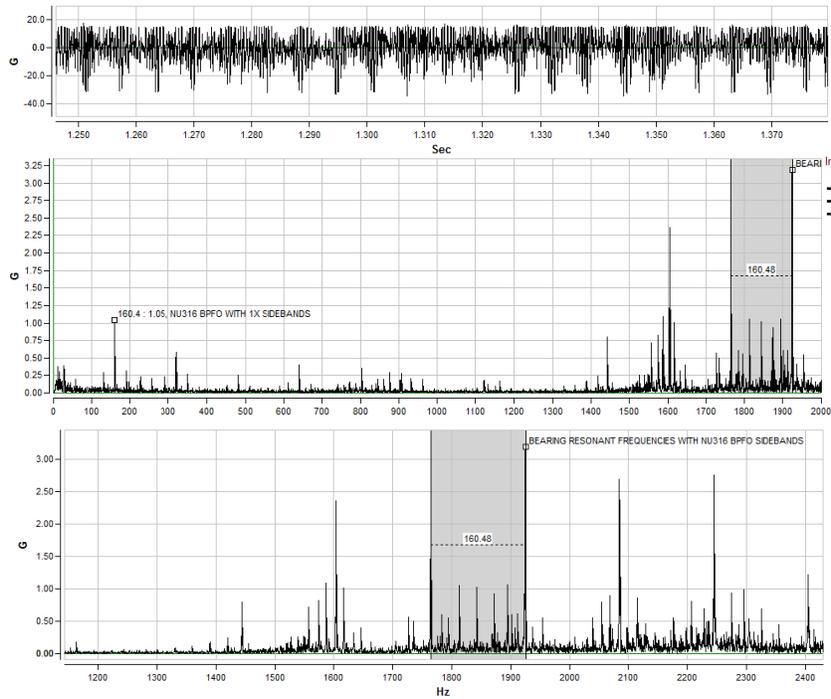
Furthermore, the high frequency (acceleration) waveform and spectrum at motor d.e. are depicted in **Figure 5**. The acceleration waveform apart from the increased energy level it is also truncated which indicates movement restriction. Additionally, the acceleration spectrum has the 5.42X frequency component with harmonics and high frequency components at the region of 1.5-2.5 kHz which correspond to bearing or structure resonant frequencies. The excitation of these frequencies can be justified by the bearing impacts occurring due to a defect at its races as the distance between the frequency peaks corresponds to the NU316 BPFO. This phenomenon can be observed clearly at the lower image, where the distance between high frequency peaks is highlighted and equals to motor d.e. bearing BPFO.

Figure 5. Motor d.e. acceleration spectrum (top) and zoomed spectrum at band of 1-2.5 kHz (bottom).

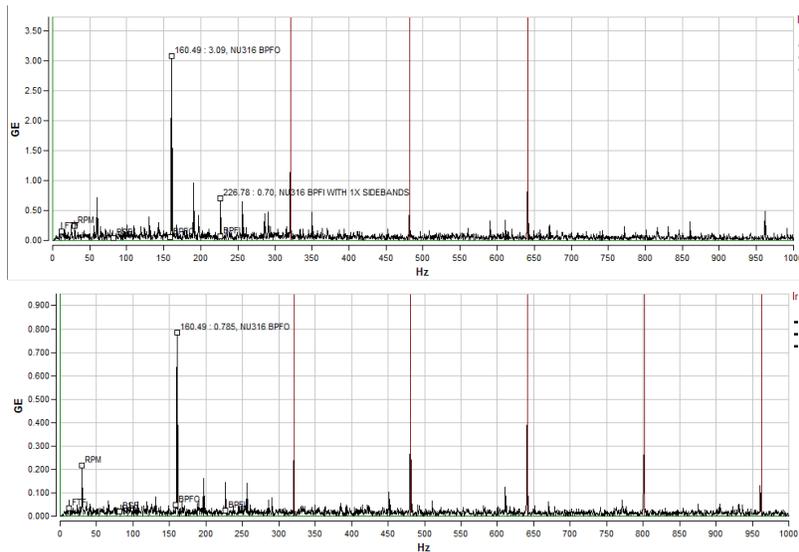
The vibration data at motor d.e. were further analyzed using envelope analysis. The results showed that the frequency component of 160.5 Hz (NU316 BPFO) and its higher order harmonics are present at demodulated spectrum. Furthermore, an attenuated frequency component of 226.8 Hz (NU316 BPF1) with motor running speed sidebands was measured. The demodulated spectrums of envelope analysis in horizontal and vertical directions of motor d.e. are shown in **Figure 6**. Although the existence of bearing CDF at demodulated spectrum can be caused due to improper lubrication, the high acceleration energy (9.5 g RMS- 48 g pk-pk) of the waveform and the aforementioned velocity spectrums indicate extensive bearing wear. Envelope analysis verifies that there is a motor d.e. bearing issue.

Figure 6. Motor d.e. demodulated spectrum in horizontal (top) and vertical (bottom) directions.

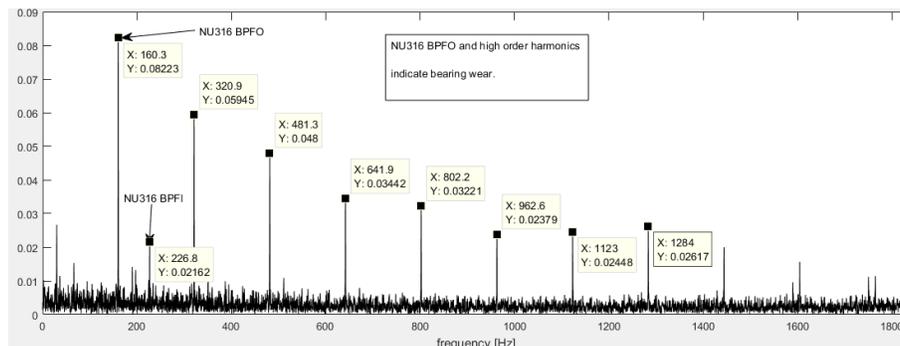
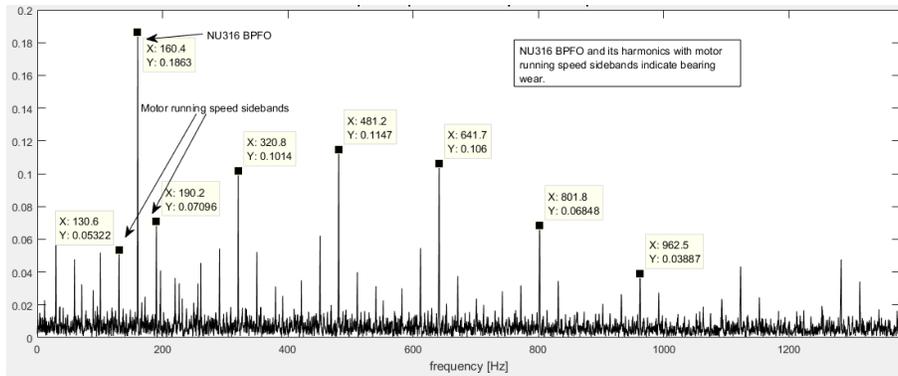
Using the method of spectral kurtosis prior the envelope analysis the results showed much more clearly the bearing fault. The fast kurtogram algorithm of Antoni (2007) was used in Matlab software in order to find the most impulsive frequency band prior to the band pass filtering. The demodulated spectrums in **Figure 7** show the presence of NU316 BPFO (160.5 Hz) and its higher order harmonics much clearly. The presence of motor running speed sidebands around the BPFO should also be noted at the demodulated spectrum. The aforementioned pattern indicates amplitude modulation. This phenomenon can be observed at the vibration data taken in the vertical direction of **Figure 7**. Furthermore, there is a frequency component (226.8 Hz) which corresponds to NU316 BPFI, but still there are not its high order harmonics present.

Figure 7. Motor d.e. demodulated spectrum in horizontal (top) and vertical (bottom) directions using band pass filter based on kurtosis values. The components of CDF are noted.

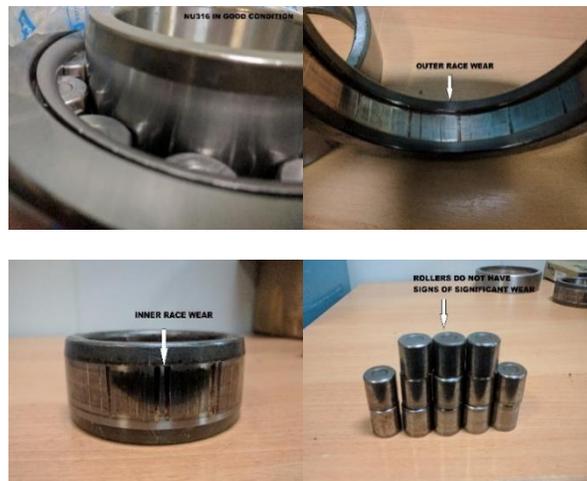
The results of vibration analysis showed the necessity of motor d.e. bearing replacement. In general, when the CDF are present at velocity spectrum and the time waveform has high energy impacting (high periodic impacts) the defective bearing is recommended to be replaced. Indeed, the results after NU316 bearing replacement show significant damage at both races (inner and outer race) and no wear at rolling elements as it can be observed in **Figure 8**. The symptom is more intense at the bearing inner race but there are not harmonics of this CDF. This can be explained from the fact that high frequency energy is severely affected by the distance of the point where the accelerometer is mounted (measurement point). This distance is also known as the signal transmission path, which has a tremendous effect on high frequency components. This is due to the fact that high frequencies are attenuated by the distance from the source of vibration to the accelerometer mounting position thus causing the high frequency information to get masked by other vibration sources. Therefore, as bearing defects initially appear in high frequency regions the improper transmission path may mask this valuable information. Furthermore, it should be noticed that the tracks created on both races are equally spaced and sized and located at the bearing load zone. It was found that they were created due to the contact of the rolling elements cage with the bearing races.

Figure 8. Motor d.e. bearing NU316 in good condition prior the replacement (top left), bearing outer race (top right), bearing inner race (bottom left) and rolling elements (bottom right).

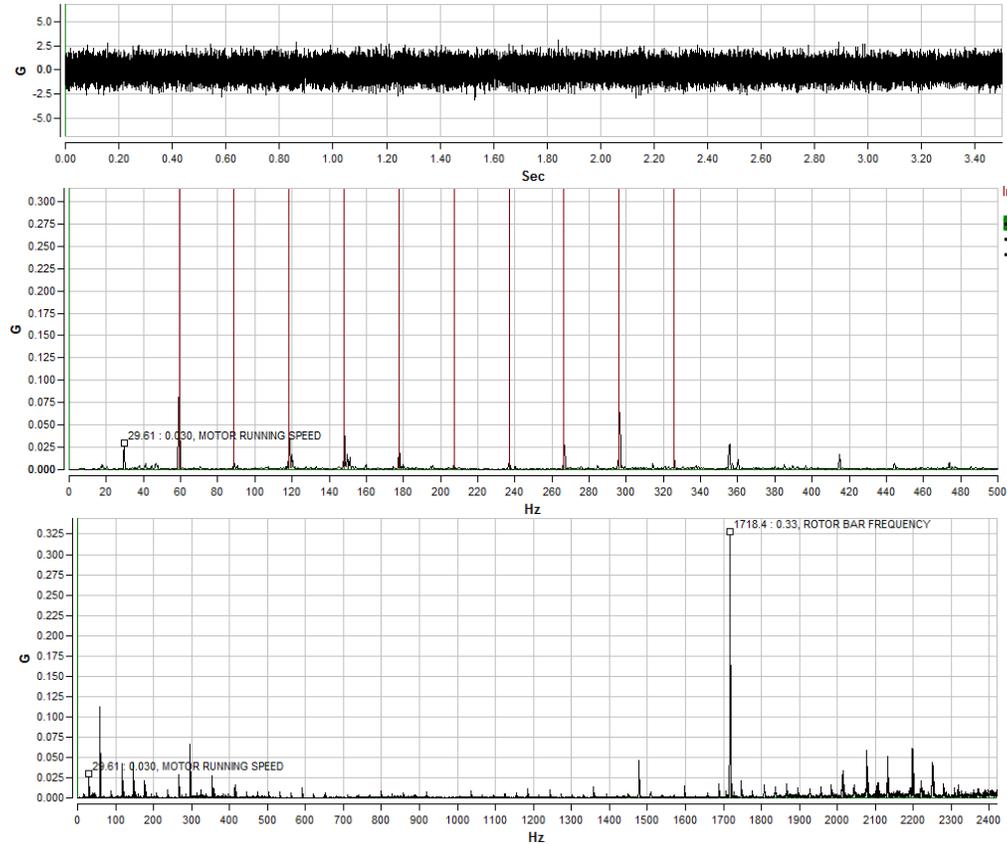
After the bearing replacement, the vibration measurements were repeated showing the absence of bearing CDF and significant energy decrease in the high frequency region. Also, envelope analysis did not show any symptoms of lack of lubrication as no frequency components of CDF were measured. The vibration data are shown in **Figure 9**.

First of all, the waveform has low RMS, pk-pk, kurtosis and crest factor values and no signs of bearing impacting. Additionally, the zoomed acceleration spectrum (figure 9 middle graph) does not contain any frequency component related to bearing CDF. Finally, the acceleration spectrum does not have energy concentration at high frequency region (over 1 kHz) and there is no bearing or structure resonant frequencies excitation. The frequency peak at 1718 Hz is not related with any bearing impacting or resonant frequency excitation but with the rotor bar frequency which is a typical pattern for electric motors. Therefore the vibration spectrum verifies that the motor d.e. bearing is in good condition.

Figure 9. Motor d.e. acceleration waveform (top), zoomed at 0-500 Hz acceleration spectrum (middle) and 0-2.5 kHz acceleration spectrum (bottom).
